PRESIDENTE NICOLAU LOBATO INTERNATIONAL AIRPORT MINISTRY OF TRANSPORTS & COMMUNICATIONS

OVERVIEW

CURRENT PNLIA CHART

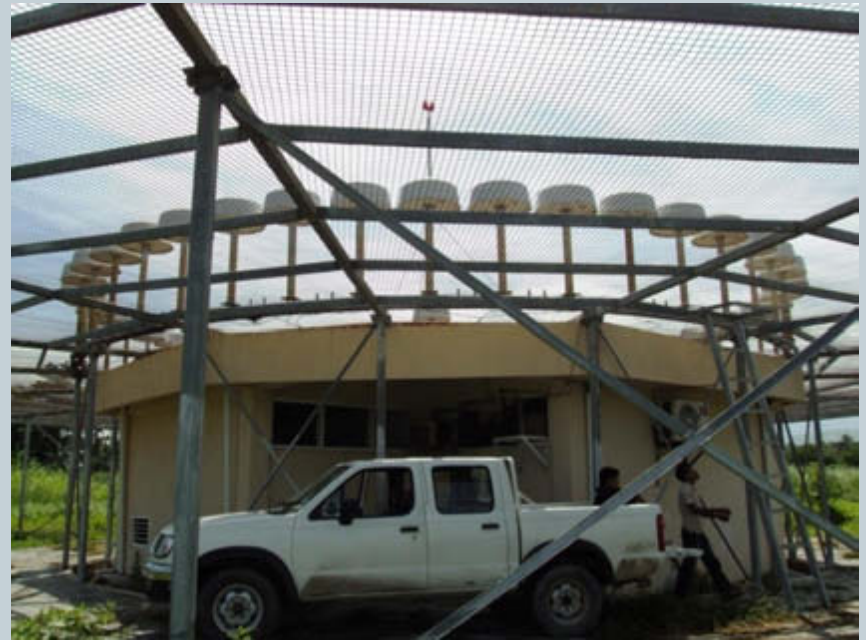
DVOR/DME

- New Doppler VHF Omni Range (DVOR) at IPNLA with dual automatic switching system.
- New ATC Radio VHF Communication and Control tower Desk Console System.
- New ATC Voice digital and Hard disc data storage recording system.
- New Airport Ambulance and rapid rescue car.
- New Airport security x-ray machine and hand baggage detector for departure passengers (public and VIPs)

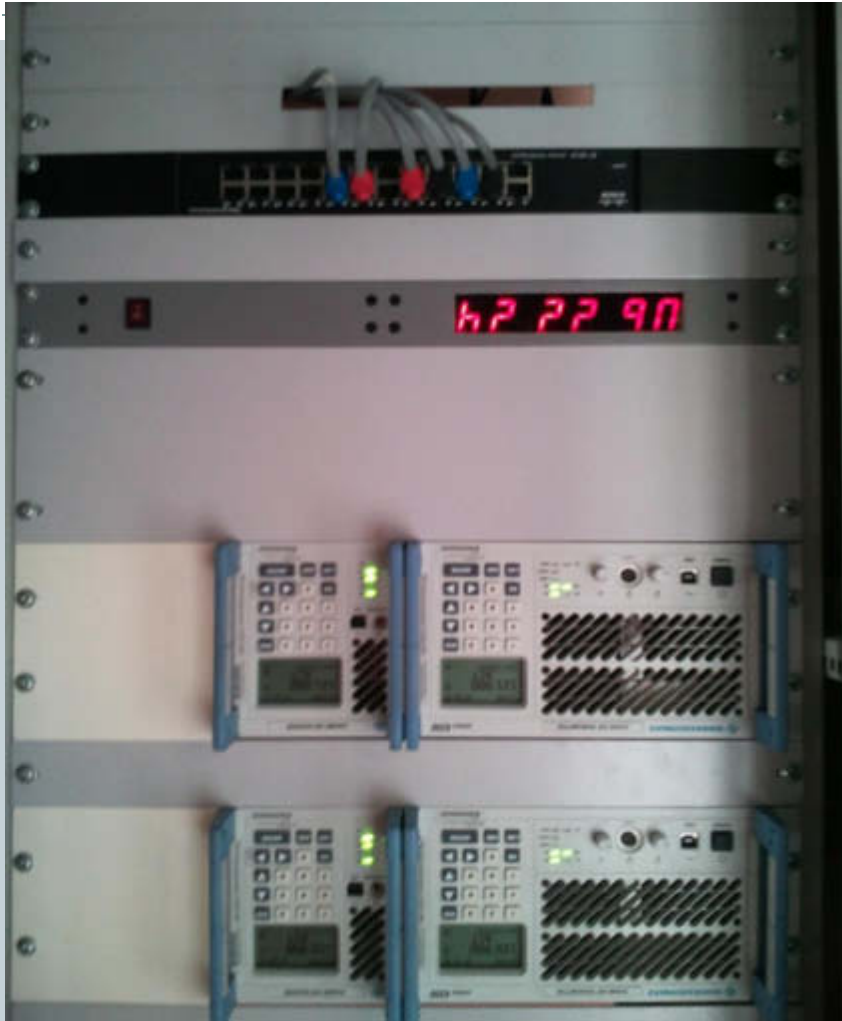
VHF transmitter and receiver

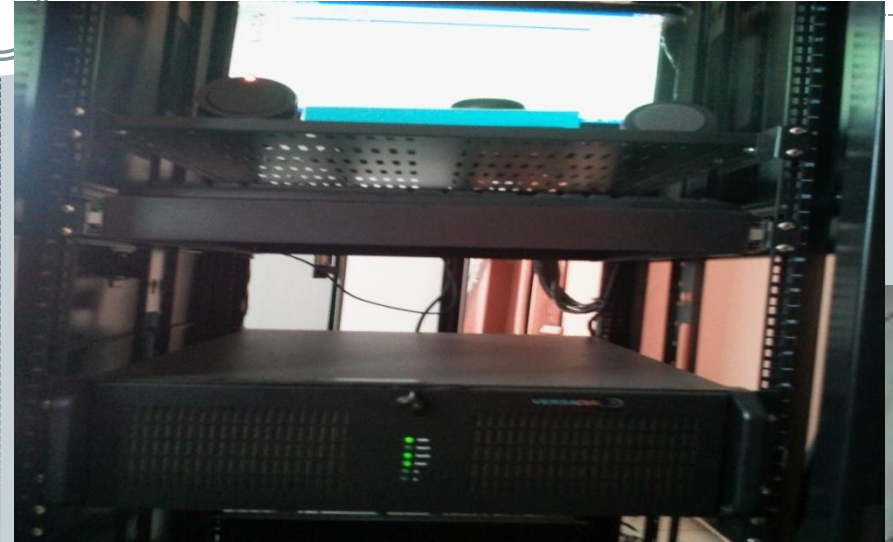
ATC voice digital and hard disc data storage recorder

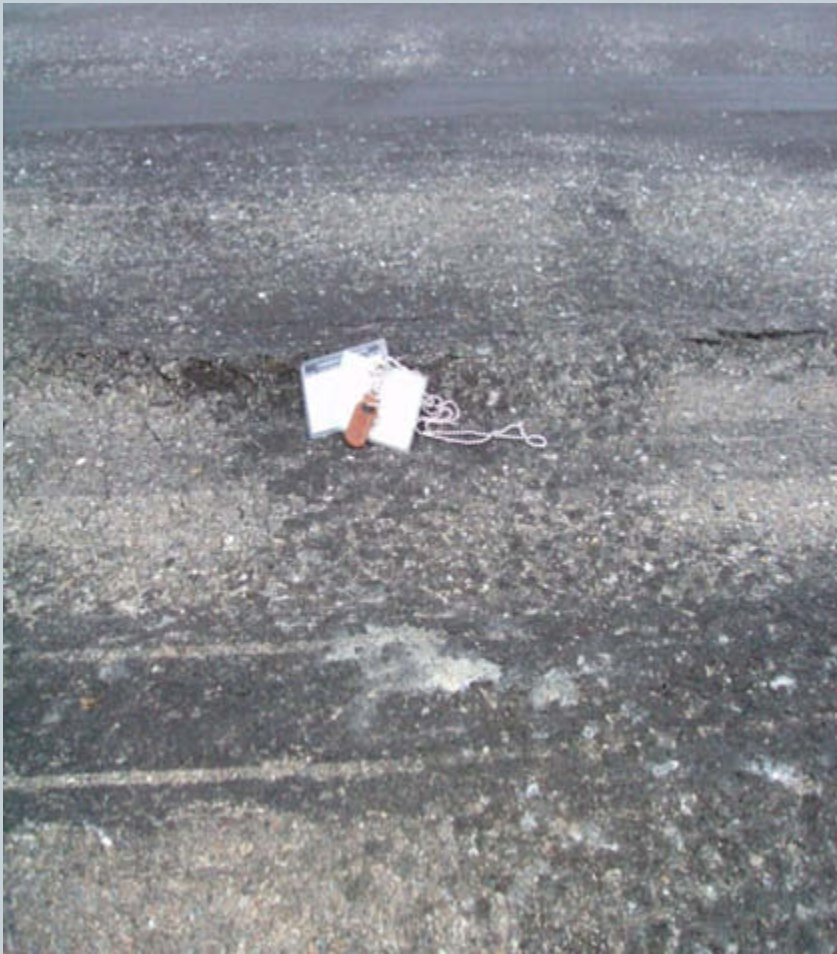
Runway condition before overlay

- Runway 08/26
- Dimension : 1850mx30m
- PCN : 32/F/B/X/T
- Declared distances:
Runway : ASDA TODA TORA LDA
08 1850m 1850m 1850m 1790m
26 1850m 1850m 1850m 1790m
- Threshold Display provided 60m from each runway end
- RESA not provided

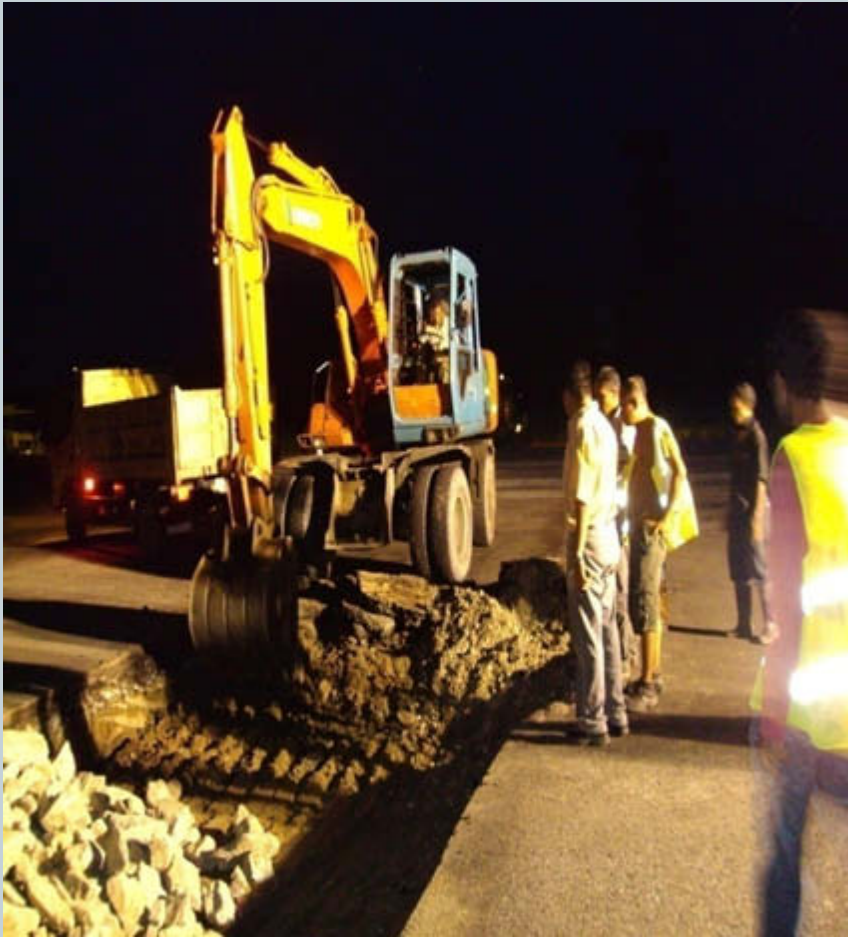
Rehabilitation of runway 26 turning pad
